VIBRATION BASED CONDITION MONITORING OF INDUCED DRAUGHT FAN: SOME INTERESTING FINDINGS

Junior Engineer (CBM Cell), Chandrapur Thermal Power Station, Chandrapur

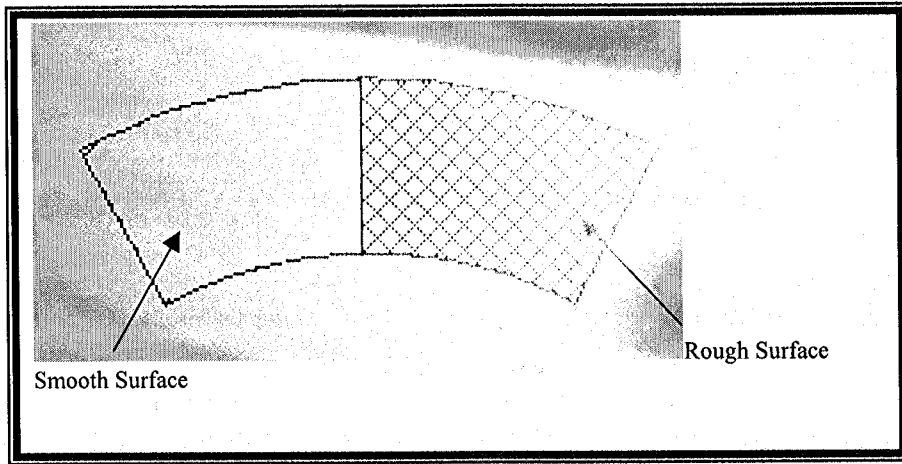
Figure 2: Blade with dual surfaces.

ID fan rotor consists of eight blades welded to the hub and end ring. Each blade forms two sections with mixed surface as shown in figure 2. One surface is extremely smooth whereas adjacent is very rough. Although we are using ESP's for fly ash collection but some part of it, along with flue gas, passes through ID fan. The blade surface is much prone to erosion due to these components. Hence we cannot keep the blades with smooth surface. Therefore some part of blade is made rough and remaining as smoother.

Another reason of this ash deposition on blade can be discussed here. At the time of light up only one air cycle comes in to service, that is only one ID fan comes in service and another is on standby mode, looking for the permissive to come in to service. At this time, the greasy fumes of flue gas gets deposited on only upper half of the stationary ID fan and dust gets stuck on only half part and create unbalance.

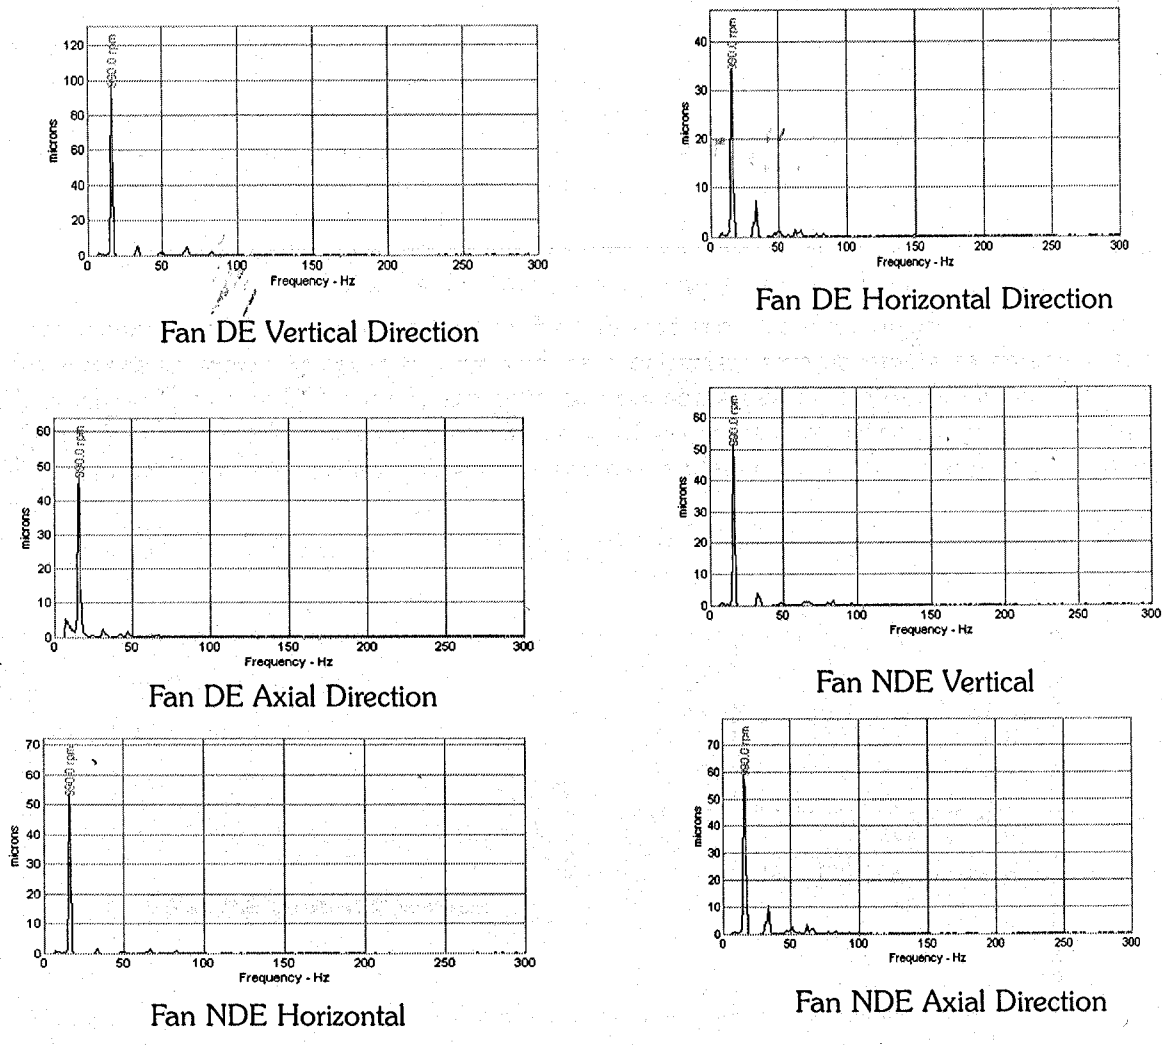
Figure 3 Signatures of ID Fan before occurrence of high vibrations.

Figure 3 (a,b,c,d,e,f) are spectrums collected before the occurrence of high vibration. The spectrums show that there is 1X component predominant in radial as well as axial direction.

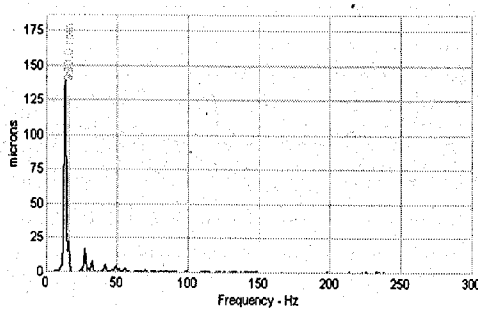
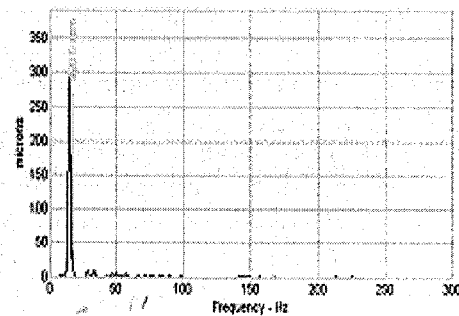
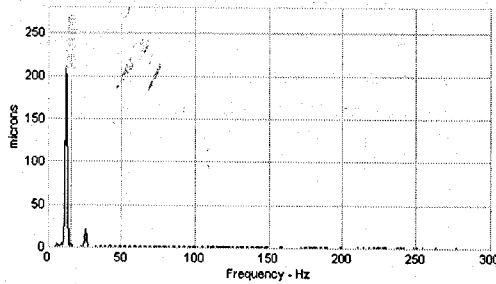
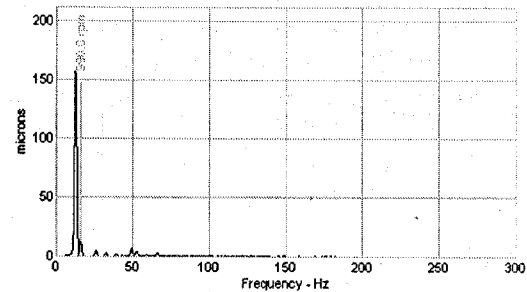
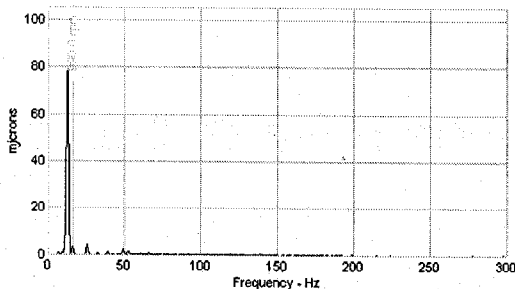
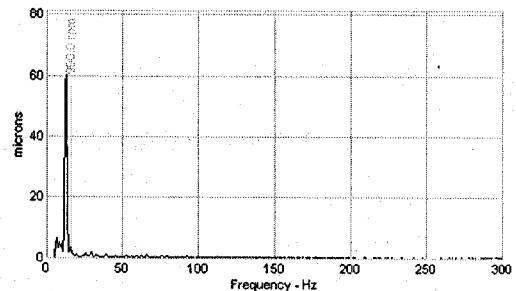
Figure 4: Vibration spectrums at maximum level

On day one (the date of increased vibrations) the vibration signature shows the 1X component as predominant at fan Driving End (DE) side as well as Non Driving End (NDE) side in radial and axial direction with increased amplitude. This indicates the unbalance at fan [1,2] along with some misalignment. The next reading taken after 45 days shows the high amplitude 1X peak with 215 microns amplitude in radial direction. Also in the axial direction this 1X component is dominating with amplitude 210 microns. It was not feasible to run the fan in such conditions. Previously it was found that by reducing the scoop (Loading of Fan), the high vibrations were reduced. Hence it was decided to reduce the scoop gradually and monitor the vibrations accordingly. Hence by gradually reducing the scoop position it was found that the fan vibrations were under acceptable zone at 55 % scoop position. Table 1 shows the vibration at different scoop positions on DE and NDE side of fan. (H- Horizontal, V - Vertical, A - Axial). The vibration spectrums having maximum vibrations are given in figure 4.

Looking at available spectrums, it can be pinpointed that only 1X component is predominant in radial as well as in axial direction. The high unbalance leads to increase in axial vibrations. Hence we concentrated only on unbalance.

were observed to be high. Thus we can correlate these high vibrations with taking the set on load. In this power plant the boiler light up starts with oil support. This oil burning produces the flue gas, which is greasy in nature. These greasy fumes get stuck up on the fan blades. Then the boiler is taken with coal support. The coal dust / un-burnt particles, while passing through ID fan, gets deposited on these greasy surfaces of fan blade. As discussed earlier the half part of blade surface is rough and forms the favorable surface for dust particles to be deposited on it. This phenomenon increases the centrifugal force on rotor and increases the vibrations. The small deposition on the surface or removing small material from rotor may act as the cause of unbalance.

The only solution to reduce these high vibrations was to carry out balancing of fan rotor. This leads to outage of auxiliary. As discussed earlier, outage of one ID fan cut one air cycle from service and we have to run the set on half load. By maintaining the scoop at 50% and keeping fan out of biasing, we ran the fan until next opportunity came for balancing. This fan was under continuous supervision as it was operated in the dangerous zone of vibrations.
